METHODIST CEMETERY

CITY OF ROSWELL CEMETERY CONDITIONS ASSESSMENT

FINAL REPORT
July 8, 2008

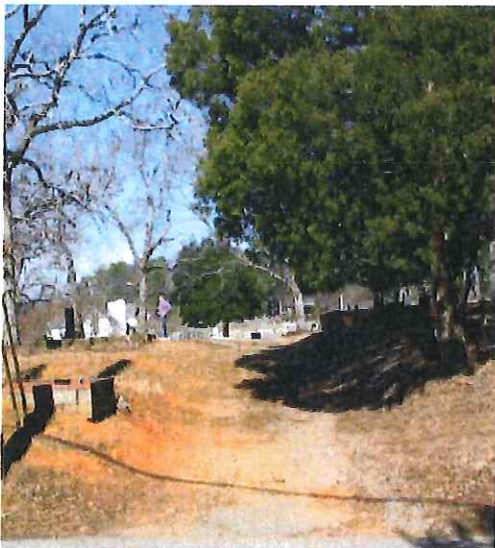
Figure 2.1 The Mount Carmel Methodist Church is believed to have been located on the crest of the knoll to the right of this access road.

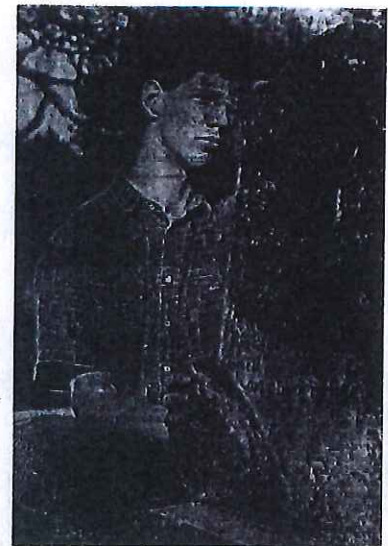
Figure 2.3 Here Michael Cole returns a stone fragment of a monument to its original location. Photo courtesy of the Roswell Library and Archives.

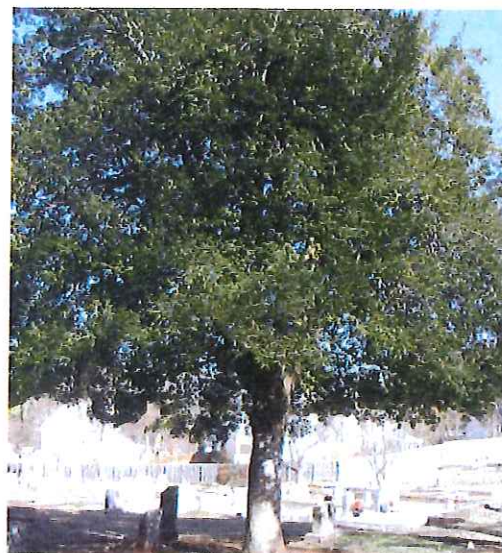
Figure 3.1 Mature American Holly tree located near existing asphalt path in the northern portion of the Cemetery.

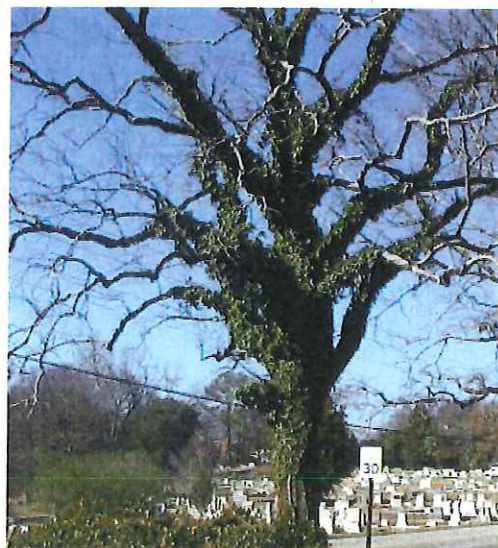
Figure 3.2 Mature oak tree with escaped English Ivy on trunk and branches.

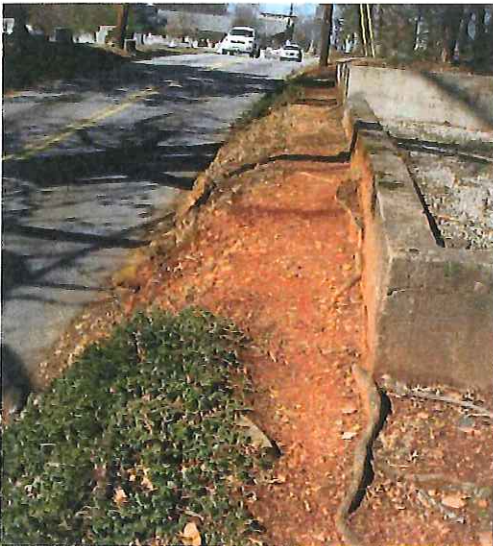
Figure 3.3 Compacted and eroded informal path along Woodstock Street.

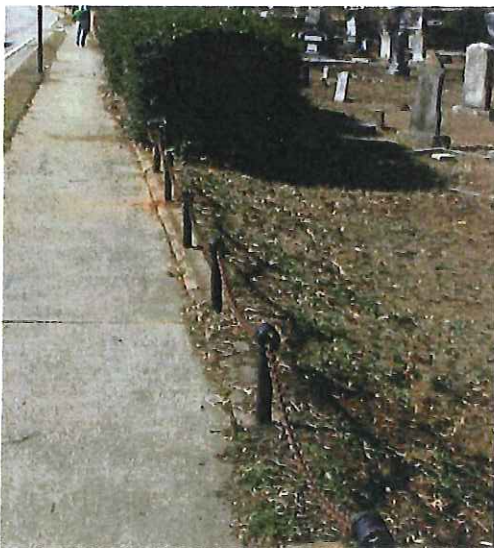
Figure 3.4 Metal chain fence along Alpharetta Street.

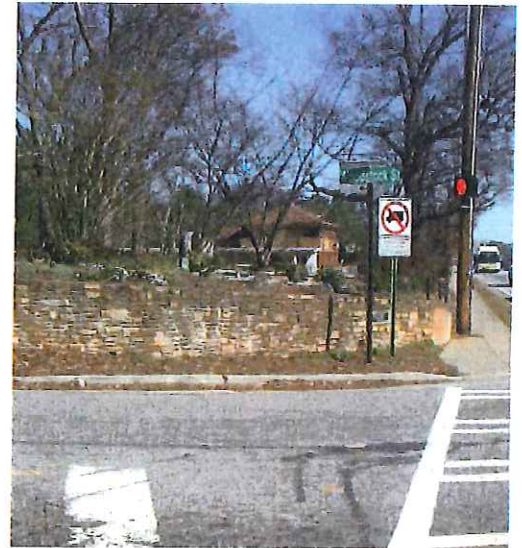
Figure 3.5 Stone entrance wall on north side of Woodstock Street.

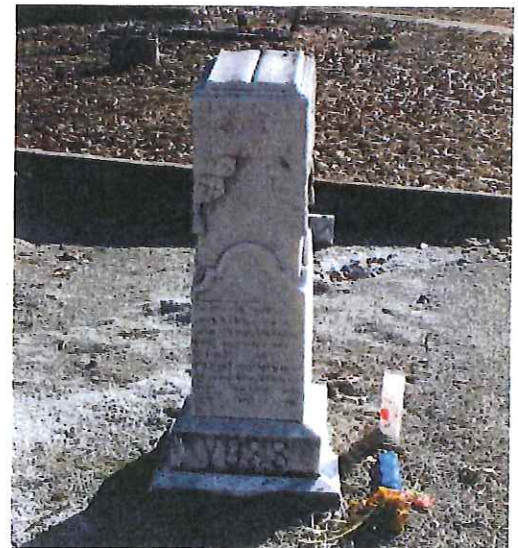
Figure 3.6 This monument, for a member of the Voss family, is a pulpit marker with delicate carvings and features the masons symbol.

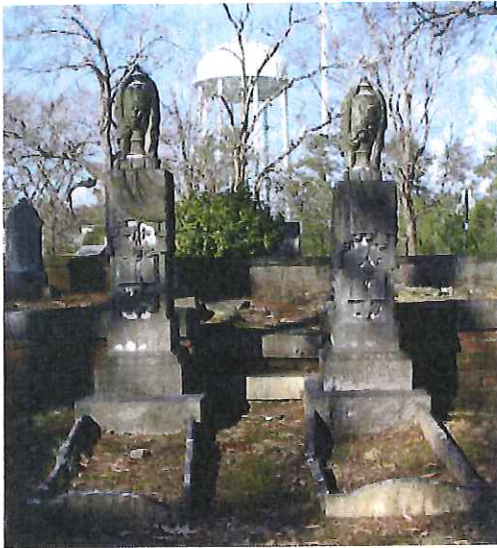
Figure 3.7 These bedsteads utilize marble obelisks with intricately carved symbolism.

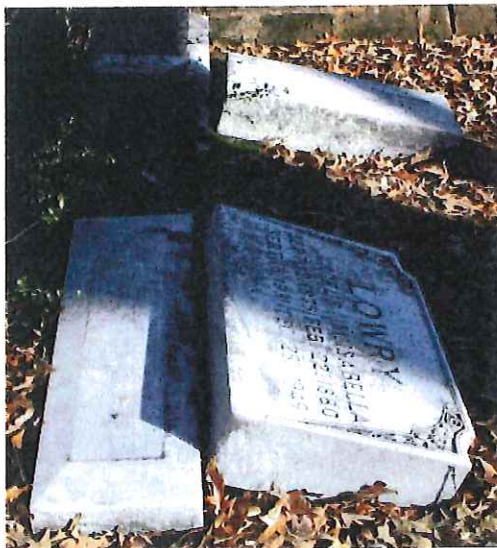
Figure 3.8 The J. Rufus and M. Isabella Lowry monument has toppled. This is a condition that can be found through the Cemetery.

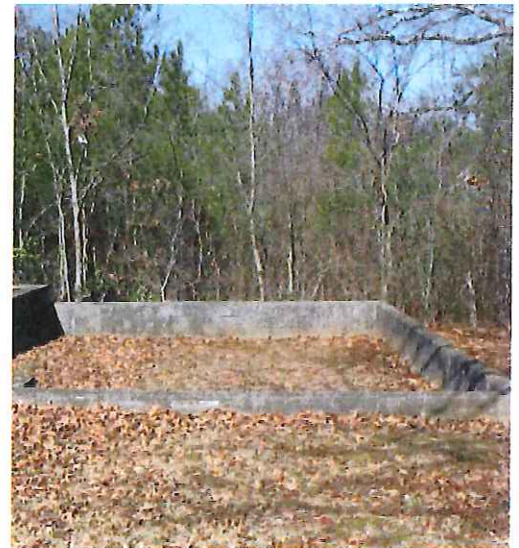
Figure 3.9 This family plot along the northern boundary of Methodist Cemetery has been outlined with stucco-covered masonry, yet no interments are marked. This suggests that interments may exist within the defined plot.

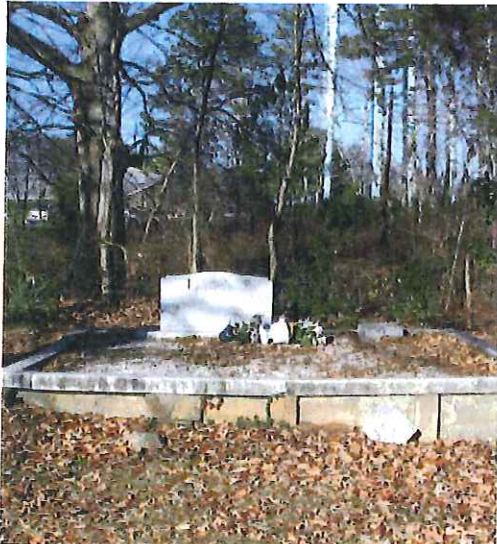
Figure 3.12 The Gray Family plot at Methodist Cemetery.

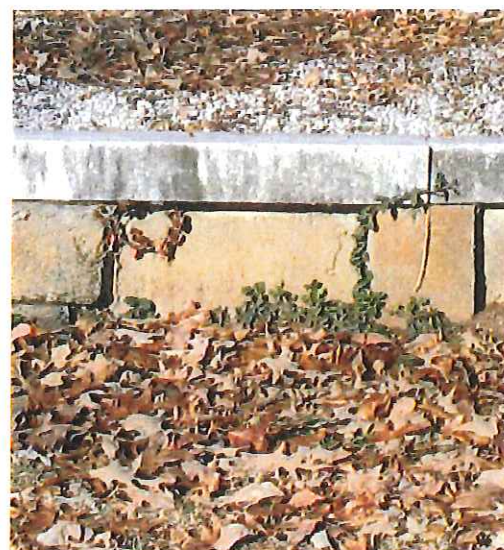
Figure 3.13 Detail of ivy growing into cracks among the concrete masonry unit blocks of the coping of the Gray family plot.

In this case study it is noted that there is ivy growing in the mortar joints and cracks of the coping of the Gray family plot. Ivy and other vegetation grows in such crevices drawing nourishment from the minerals in the mortar. This in turn weakens the mortar strength and as root systems grow this will slowly break the coping apart. Upon inspection of the plot by the qualified staff person of the administrative body of the Roswell Historic Cemeteries it should be noted that this can be addressed by volunteer staff. The coping and the plot itself is stable and in good condition.

Using pruning shears a volunteer may sever the ivy at its root. Care should be taken not to damage the coping. The ivy should be allowed to die (approximately one week) before it is removed

by hand (wearing protective gloves) from the cracks and mortar joints. It is important to allow the ivy die as it will then shrink and die making it easier to remove from crevices. A herbicide that will not cause detriment to the coping could then be sprayed on the root system.

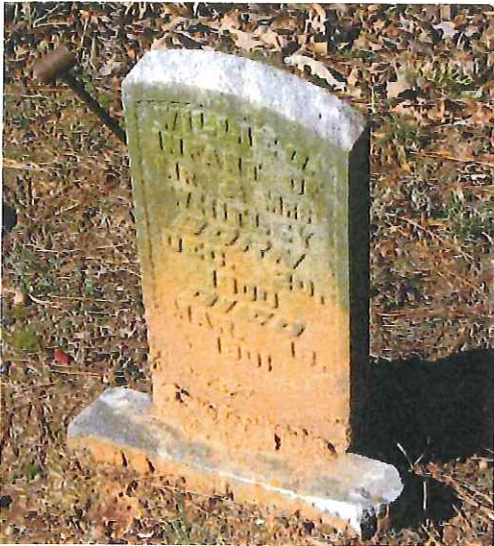
Figure 3.14 The Willie G. Whitley headstone, Old Methodist Cemetery.

In this case study it is noted that there is significant biological staining on the headstone and that a corner marker has been leaned against its base. Upon inspection of the plot by a qualified staff person of the Roswell Historic Cemeteries, it should be

noted that the headstone is sturdy enough to be cleaned. Previous experience with monument cleaning is necessary as care still needs to be taken when cleaning headstones due to their shallow thickness. Prior to cleaning the stone the corner marker should be appropriately removed from the base of the headstone and stored.

To begin work on this headstone, staff/volunteers should photograph the corner marker in its current condition and location. It should also be noted on a map and an appropriate entry should be made into the cemetery log book of the cemetery to become part of the permanent record. As there is currently no storage facility for migrated fragments this corner marker should be buried underground (*refer to Preservation & Rehabilitation Recommendations on page 21*). To do this:

1. Record location on cemetery map
2. Photograph the corner marker in place
3. Approximately 2' from the headstone, dig a hole large enough to place the corner marker in that when filled would maintain approximately 6" of soil and sod between the marker and grade
4. Place approximately 2" of clean, graded sand in the bottom of the hole for drainage and to support any irregularities of the stone
5. Carefully place the stone flat, face up in the sand
6. Cover the fragment with clean, graded sand (particularly if the soil could stain the fragment) prior to filling the hole with the displaced dirt and sod from the hole.
7. After work has been completed and entered into the cemetery log book, the location of the buried corner marker should be noted so that it is easily recovered and returned to its original site.

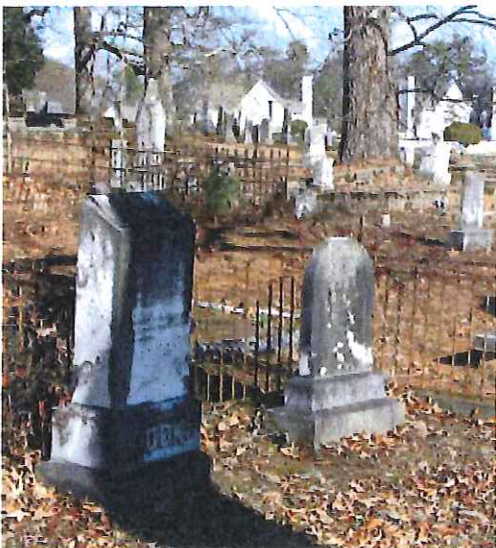
Figure 3.15 The Colson M. Hook pulpit marker at the Methodist Cemetery.

In this case study it is noted that there is significant biological staining on the headstone and the cast iron fence is in disrepair. Upon inspection of the plot by a qualified staff person of the administrative body of the Roswell Historic Cemeteries, it should be noted that due to the significant amount of biological staining, the monument needs to be cleaned using a poultice cleaning method. Such methods require training and should only be undertaken by professionals. Until a staff person has undergone the necessary training this monument will have to be left as is or a professional will need to be hired as the budget allows.

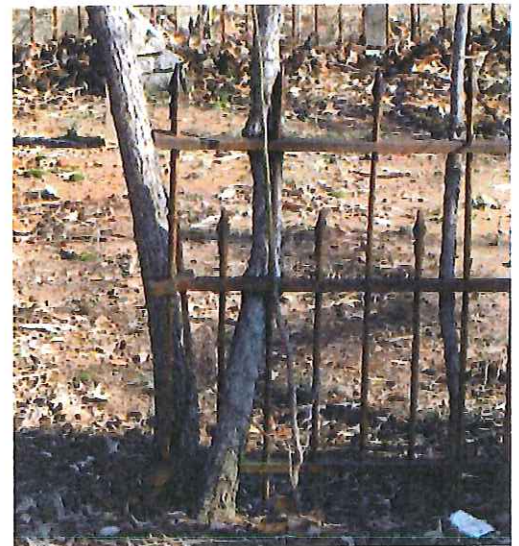
Upon inspection the cast iron fence the staff person should note that the fence has scrub trees growing around its spindles and it has rusted. To remedy this situation three tasks need to be performed:

Figure 3.16 Scrub trees have grown up through and around the cast iron fence of the Hook family plot.

1) removal of vegetation growing on and around the fence; 2) cleaning and sealing of the extant fencing; and 3) restoration of the missing fence sections.

Task 1 may be undertaken by volunteer staff. Using a small handsaw the volunteer may sever the trunks of the scrub tree near its root. Care should be taken not to damage the fencing during this procedure. The vegetation should be allowed to die (approximately one to two months as needed) before it is removed. To remove a trunk that has intertwined with the fence, further severing of the trunk may be warranted. This must be done with extreme caution. Due to the delicate nature of this task administrative staff should be present. It is important to let the scrub trees and other vine-like vegetation have a chance to die causing it to shrink and become brittle making it easier to remove from crevices. A herbicide that will not cause damage to the coping may then be sprayed on the root system to further insure the vegetation does not grow back.

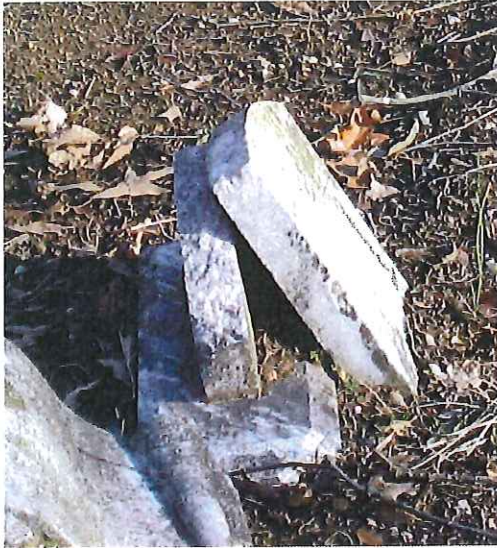
Figure 4.2 This die in socket monument found in the northern portion of Methodist Cemetery has been broken by vandals. Until it can be repaired it should either be stored off site, or buried next to its base.

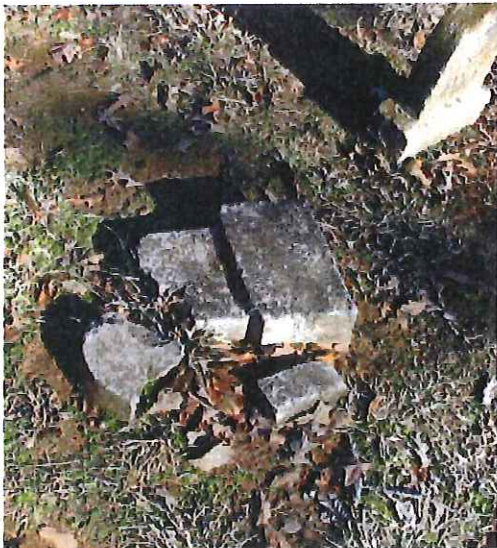
Figure 4.3 This shattered headstone found in the northern half of the Cemetery should be carefully cataloged and stored so that it can be repaired. If left as is these fragments could be separated and lost.

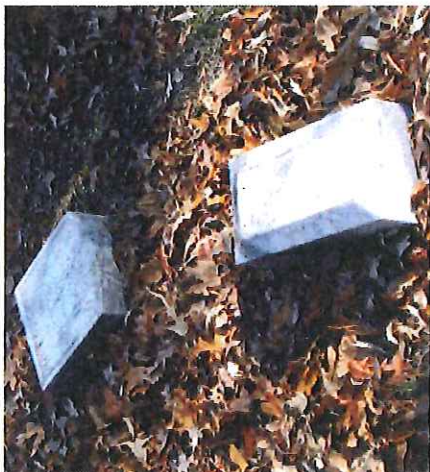
Case Study of the Rollie B. Green monument: This die on base monument has been vandalized causing the die to be separated from its base. This die should be appropriately stored so that the die is not lost by further vandalism. This is an instance where the fragment could be buried 4" - 6" below grade adjacent to the base.

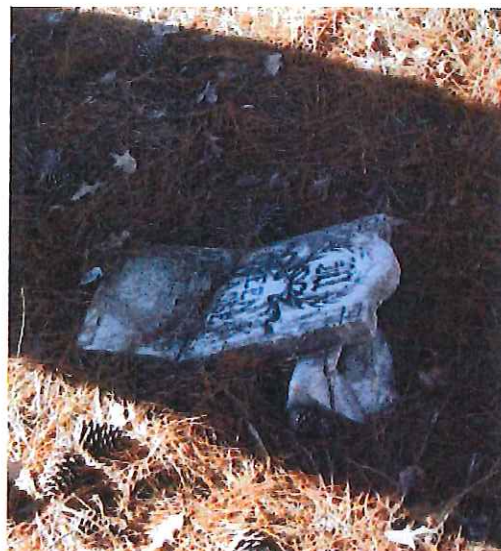
Figure 4.4 Due to the placement of this tablet for Oren K. Massey against its base, a vandal was able to break this tablet into smaller fragments. Fragments of monuments should never be placed against their base as it promotes vandalism.

- ① Any dismantled headstones, or other monument fragments, should not be stored leaning against a monument base, coping, retaining wall, or other monument. Such fragments should be stored in an archive, under control of the Roswell Historic Cemeteries until the monument can be reset. Another option for storing of fragments is burying them, see recommendation above. Refer to Rollie B. Green Case Study.
- ① Chemical herbicides and pesticides are not encouraged in the vicinity of monuments. If chemical herbicides or pesticides are warranted they should be thoroughly researched regarding

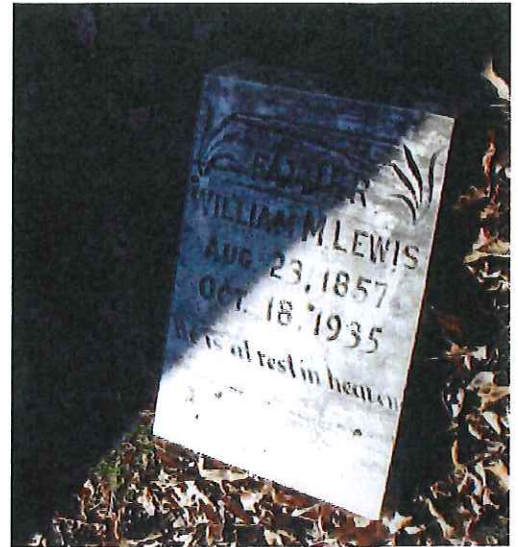
Figure 4.5 The William M. Lewis headstone has been toppled. Lawn mowers should not mow over or near this monument as damage would likely occur.

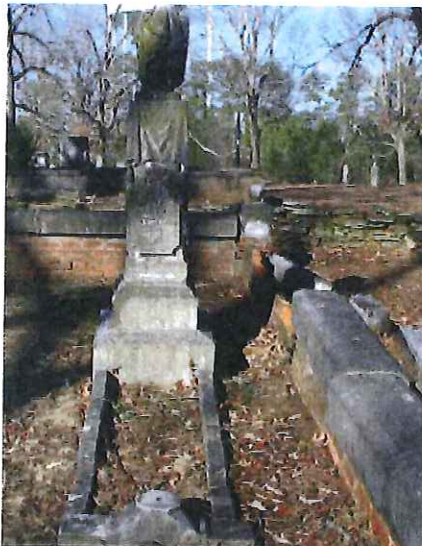
Case Study of the Mettie Weaver monument: This obelisk is constructed of marble. Great care must be used when cleaning marble to prevent sugaring. Cleaning agents with a low or neutral PH are preferred as the typical cleaning agent for such monuments.

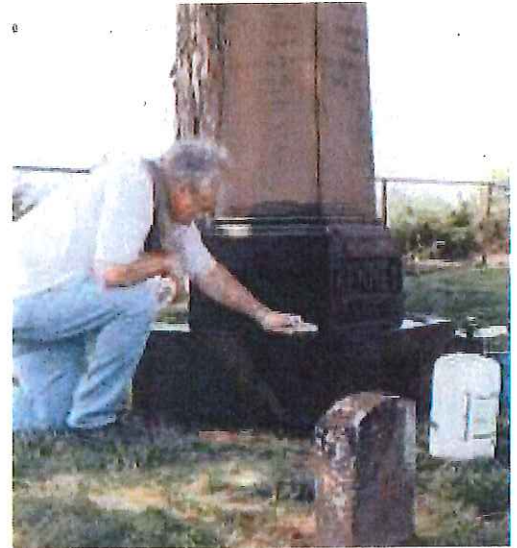
Figure 4.6 As in this example, monuments should be pre-wetted prior to the start of the cleaning process and should be cleaned from the bottom up. Photo courtesy of Connecticut Gravestone Network.

- ② Always clean a stone from the bottom up to avoid streaking. Refer to Figure 4.6.
- ② Before utilizing a cleaning agent, clean the monument with water (preferably distilled) and a short bristled brush.

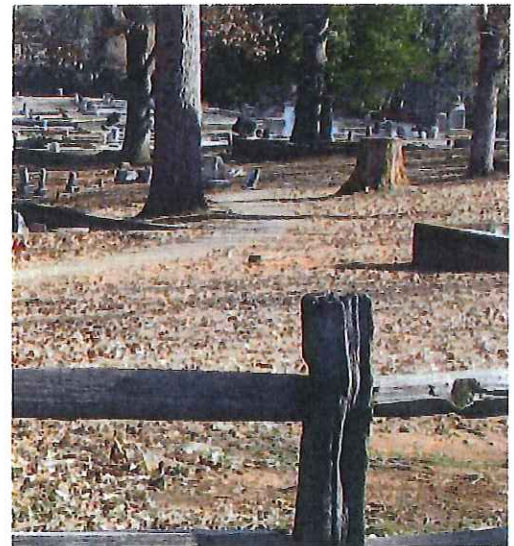
Figure 4.8 The 1980s sidewalk through the Cemetery is not appropriate. Installation of another ground disturbing feature would be detrimental to unmarked and marked graves, therefore it should be avoided.

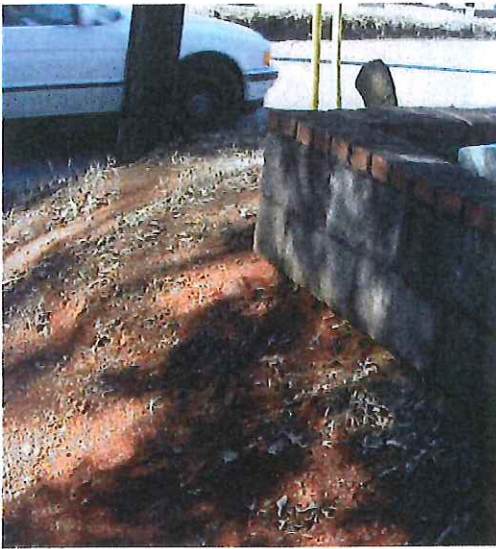
Figure 4.9 This coping is being undermined by erosion along this access road off of Woodstock Street. It is important to halt such erosion.

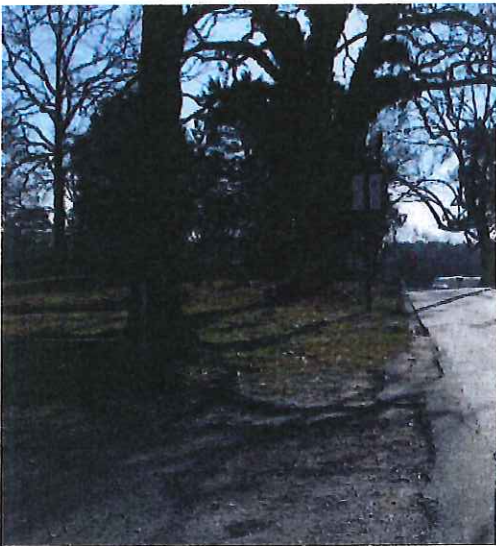
Figure 4.10 The parking lot adjacent to Woodstock Street should be removed as it is not appropriate to Methodist Cemetery.

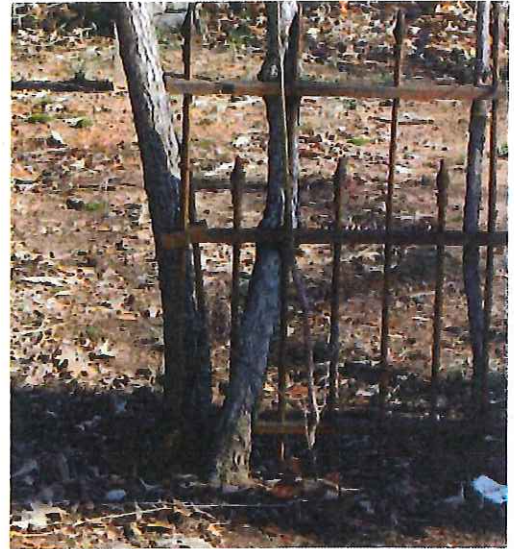
Figure 4.11 These trees should have been removed when they were saplings. If they had been removed the damage to the cast iron fence would not have occurred. Historic cast iron fences are a character-defining feature of any cemetery and should be maintained appropriately.

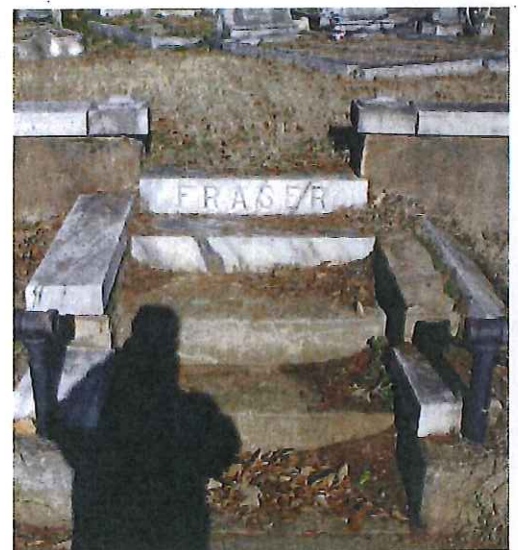
Figure 4.12 These marble steps into the Fraser family plot off of Alpharetta Street are important hardscape features that should be maintained.

- ② It is important that the steps from family plots to Alpharetta and Woodstock Street be maintained for their historic character defining features. These steps can be of concrete, marble, granite or other masonry and treatments should bear in mind their original purpose and material needs. Refer to Figure 4.12 on page 30.

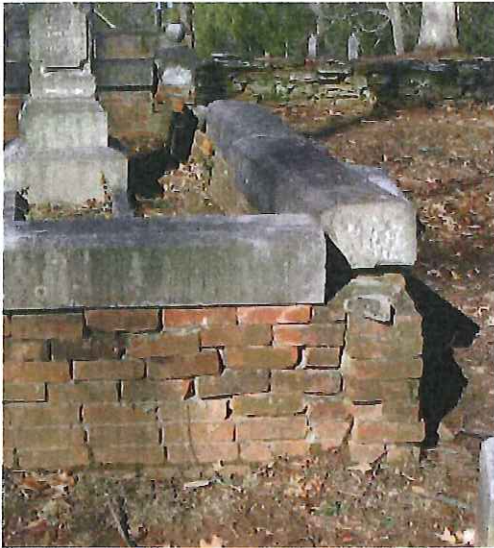
Figure 4.13 The coping surrounding this family plot near the original site of the Mt. Carmel Baptist Church is in need of repointing.

- ② Copings and retaining walls present in this Cemetery range from good to fair condition. In most cases repointing of the masonry is all that is needed. It is important that any mortar used when repointing does not exceed the current strength of the extant mortar. New mortar should also match the old in

texture, color and general appearance. *Refer to Figure 4.13.*

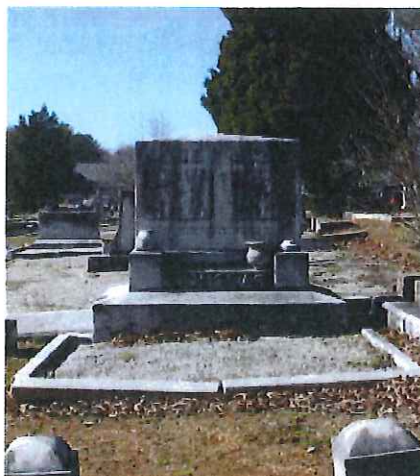
Case Study of the Douglas family plot: This family plot utilizes pea gravel for the ground cover within the coping of the plot. The use of concrete for this ground cover would be inappropriate and would cause damage to the headstone monument.
