**Subject: State Waters Verification
Azalea Drive Site
Fulton County, Georgia
CEG Project No. 02-051713**

Corblu Ecology Group (CEG) is pleased to provide this report of our recent state waters assessment for the approximately 7.5 – acre project site located north of Azalea Drive and south of Valley Ridge Drive in Roswell, Georgia (34° 00' 10.8" N, -84° 21' 57.5994" W) (Figure 1). CEG conducted an initial site investigation on November 13, 2013. A field verification of our findings was conducted with you on February 10, 2014.

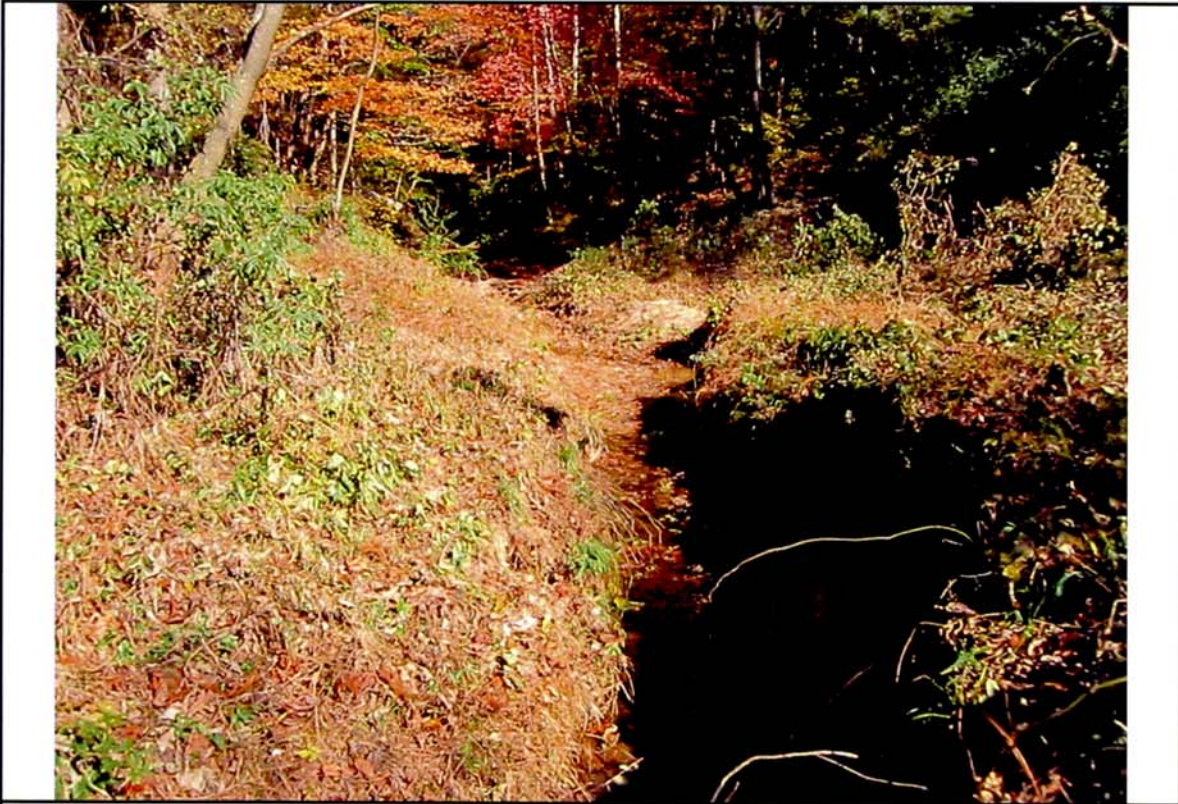
Photograph No. 1: View of perennial stream (P1) facing north.

Corblu personnel delineated one unnamed perennial stream (P1) and one wetland area (W1) on the project site (Photograph Nos. 1-2, Figure 2). The stream delineated on the project site (P1) is considered a state waters requiring a buffer.

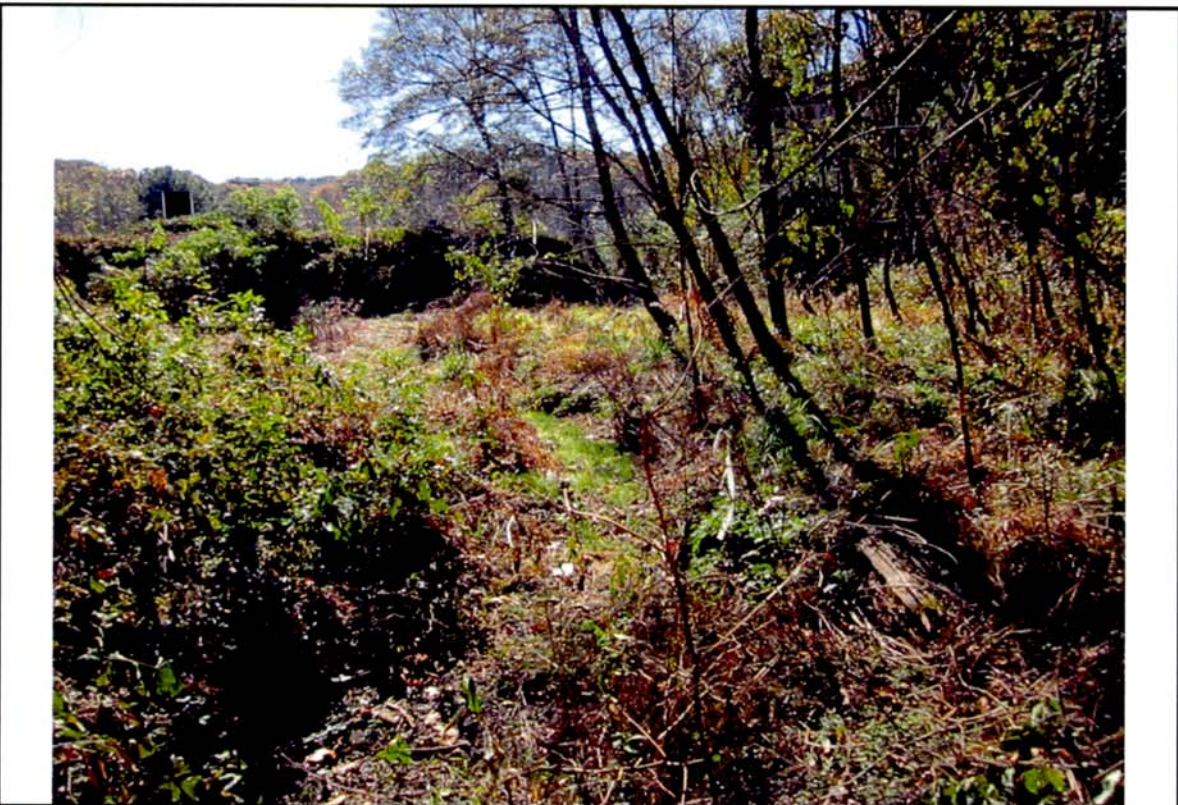
Photograph No. 2: View wetland (W1) facing south towards old dam feature.

It appears that the unnamed perennial stream (P1) on site was relocated to the east for the purposes of forming an impoundment which is no longer present. The dam forming the impoundment was breached several years ago and the stream shifted back to its original channel creating the current wetland feature (W1). A wetland seep located in the north eastern edge of W1 along with the overflow of P1 during storm events contributes to the wetlands hydrology.
